## EAA COMPANY LIMITED / Vehicle Roadworthiness Inspection Report

S/No. **TR-2007-131-001**

Chassis No: **NCP60-0066852** Model: **UA-NCP60** Engine Model: **2NZ**  
 Maker: **TOYOTA** 1st Registration Year: **2003/02** Engine No: **2568697**  
 Model Name: \_\_\_\_\_ Manufacture Year: **2003** Weight: **1000** Kg  
 Engine Capacity: **1290** cc Type of Vehicle: **Sedan** FF Axis Weight: **610** Kg  
 Body Color: **Silver** Mileage(Paper): **59,700** Km FR Axis Weight: \_\_\_\_\_ Kg  
 Fuel Type: **GASOLINE** Odometer: **67,387** km RF Axis Weight: \_\_\_\_\_ Kg  
 RR Axis Weight: **390** Kg

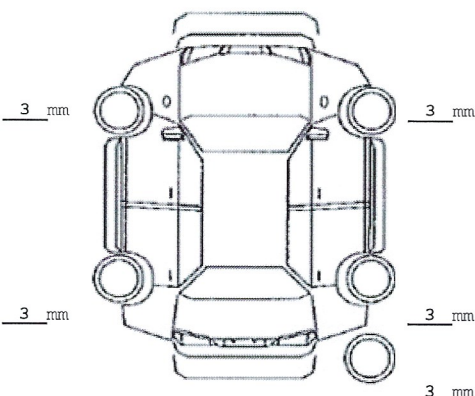
Exterior ☒ Result  
 Interior ☒  
 Underbody ☒
