EAA COMPANY LIMITED / Vehicle Roadworthiness Inspection Report

S/No. TH-2007-119-002

Chassis No:	NCP60-0181647	Model:	CBA-NCP60	Engine Model:	2NZ
Maker:	TOYOTA	1st Registration Year:	2004/09	Engine No:	3332511
Model Name:		Manufacture Year:	2004	Weight:	1010 Kg
Engine Capacity:	1290 cc	Type of Vehicle:	Sedan	FF Axis Weight:	620 Kg
Body Color:	Blue	Mileage(Paper):	76,000 Km	FR Axis Weight:	Kg
Fuel Type:	GASOLINE	Odometer:	78,900 km	RF Axis Weight:	Kg
				RR Axis Weight:	390 Kg

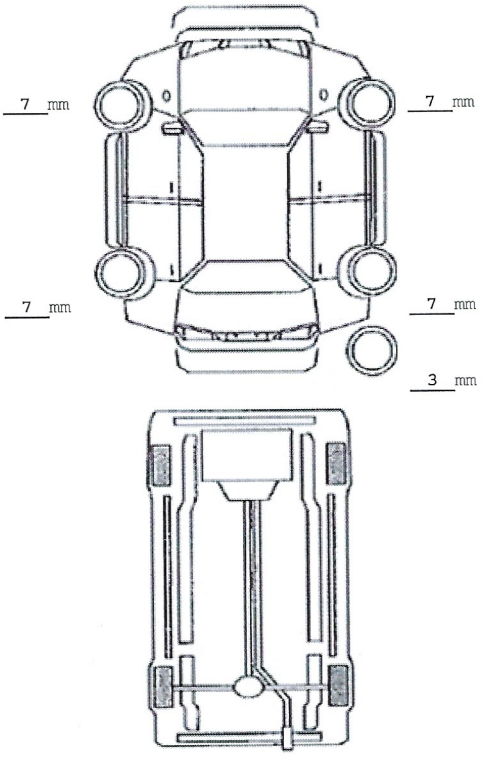
①Tyre Condition : Tyre has insufficient tread
